# Bezares USA Technical Bulletin

Date: March 2024

**Endurant transmissions may inconsistently receive PTO feedback signals. Changing the PTO confirmation (Ball Switch and Harness) may improve communication to the Eaton Endurant and PACCAR Transmissions.**

**4100/4110 MECHANICAL BALL SWITCH CONVERSION KIT**

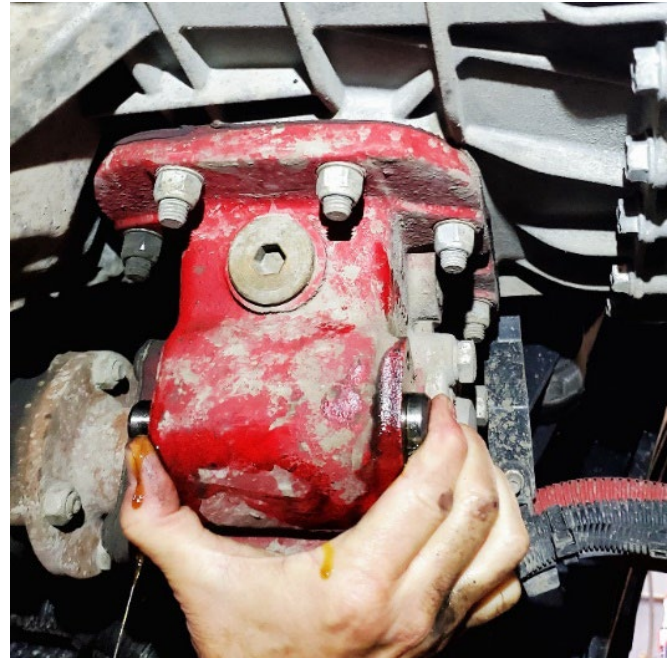
If piston does not spring back, then PTO will have to be removed for inspection. If it is found that internal shifter components have become dislodged, the unit will need to be returned to authorized Bezares distributor for rebuild.

6. Push in piston. Release and it should spring back.
